NASA Technical Paper 1481

Light Airplane Crash Tests at Three Pitch Angles

Victor L. Vaughan, Jr., and Emilio Alfaro-Bou

NOVEMBER 1979

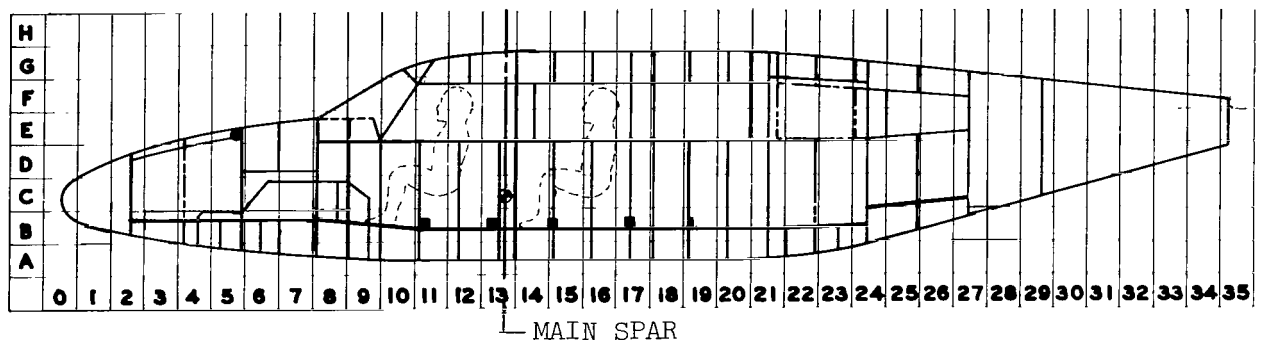
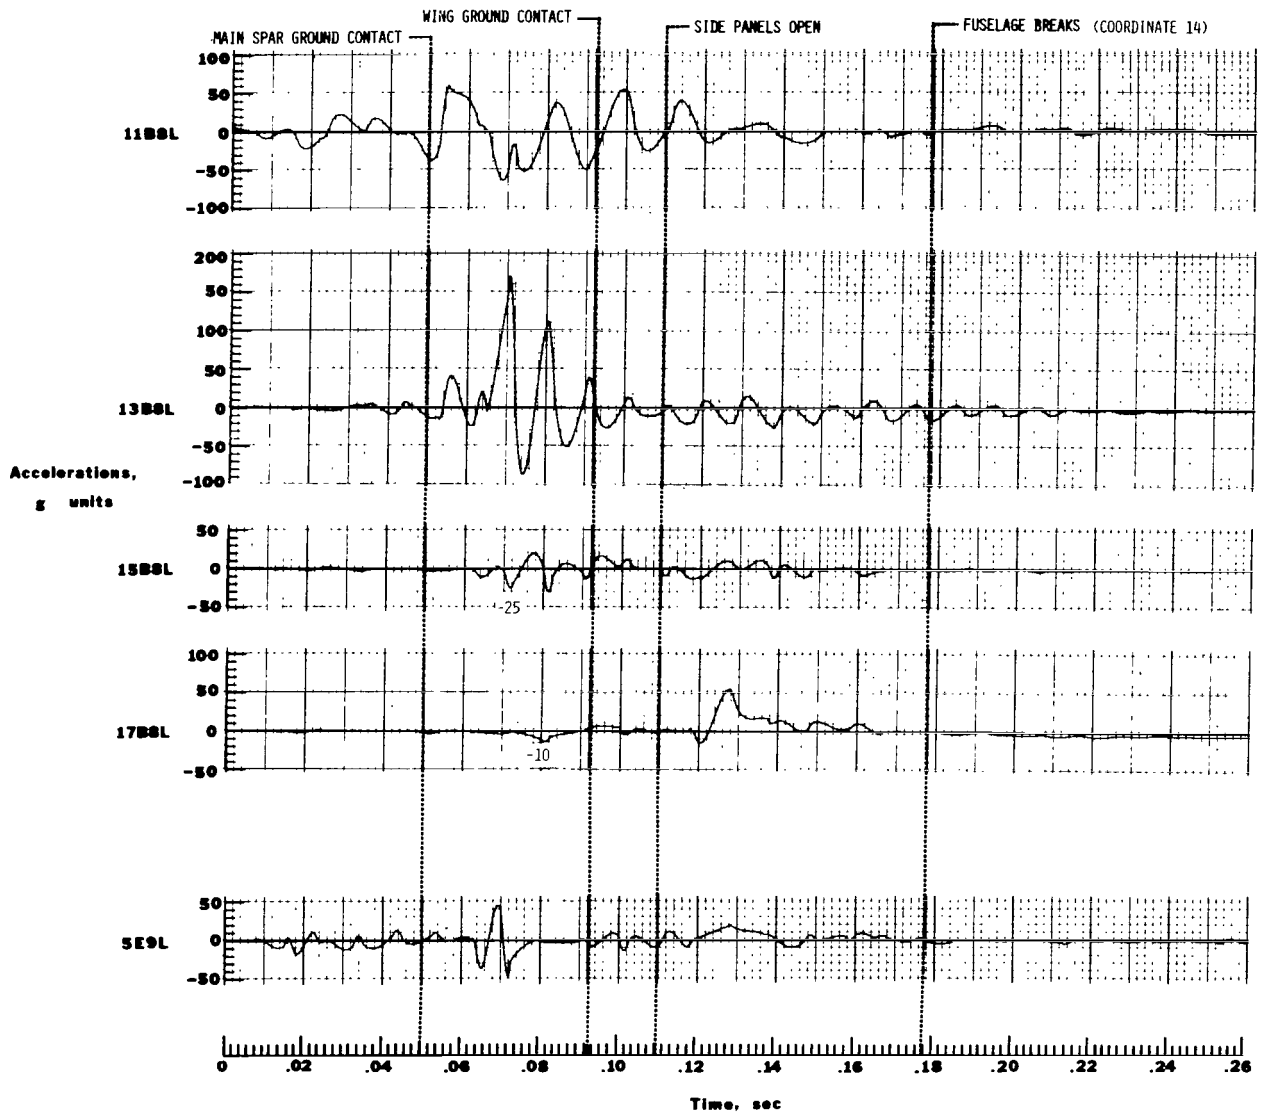
Figure 22.- Histories of roof and floor longitudinal accelerations.

Accelerations on the floor (other than the floor beam) and along the roof are presented in figure 21 in the normal direction and in figure 22 in the longitudinal direction. The accelerometers at frames 11B8 and 13B8 were mounted on the aluminum floor boards between the pilot's fore and aft seat legs. As a result of this mounting, the acceleration traces show an oscillatory behavior that is typical of a local vibration. The large acceleration peaks are a result of the impact superimposed on the oscillatory traces. The window side

(a) Pitch-down test.

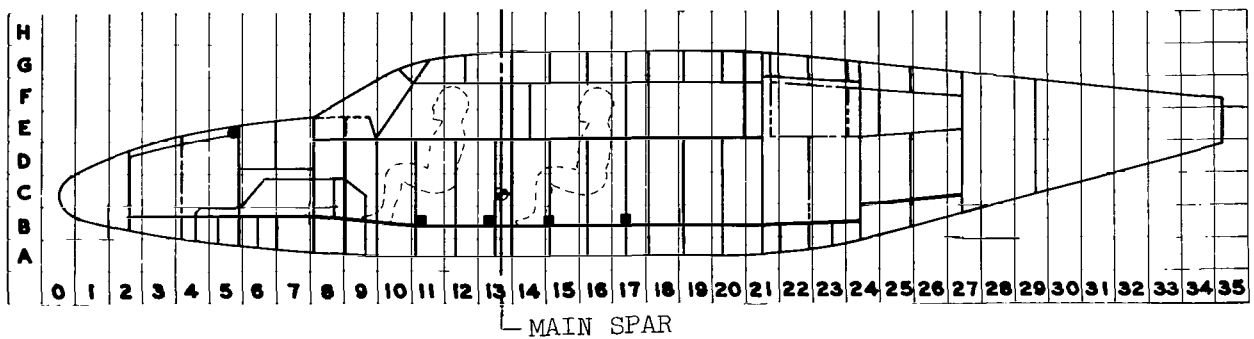
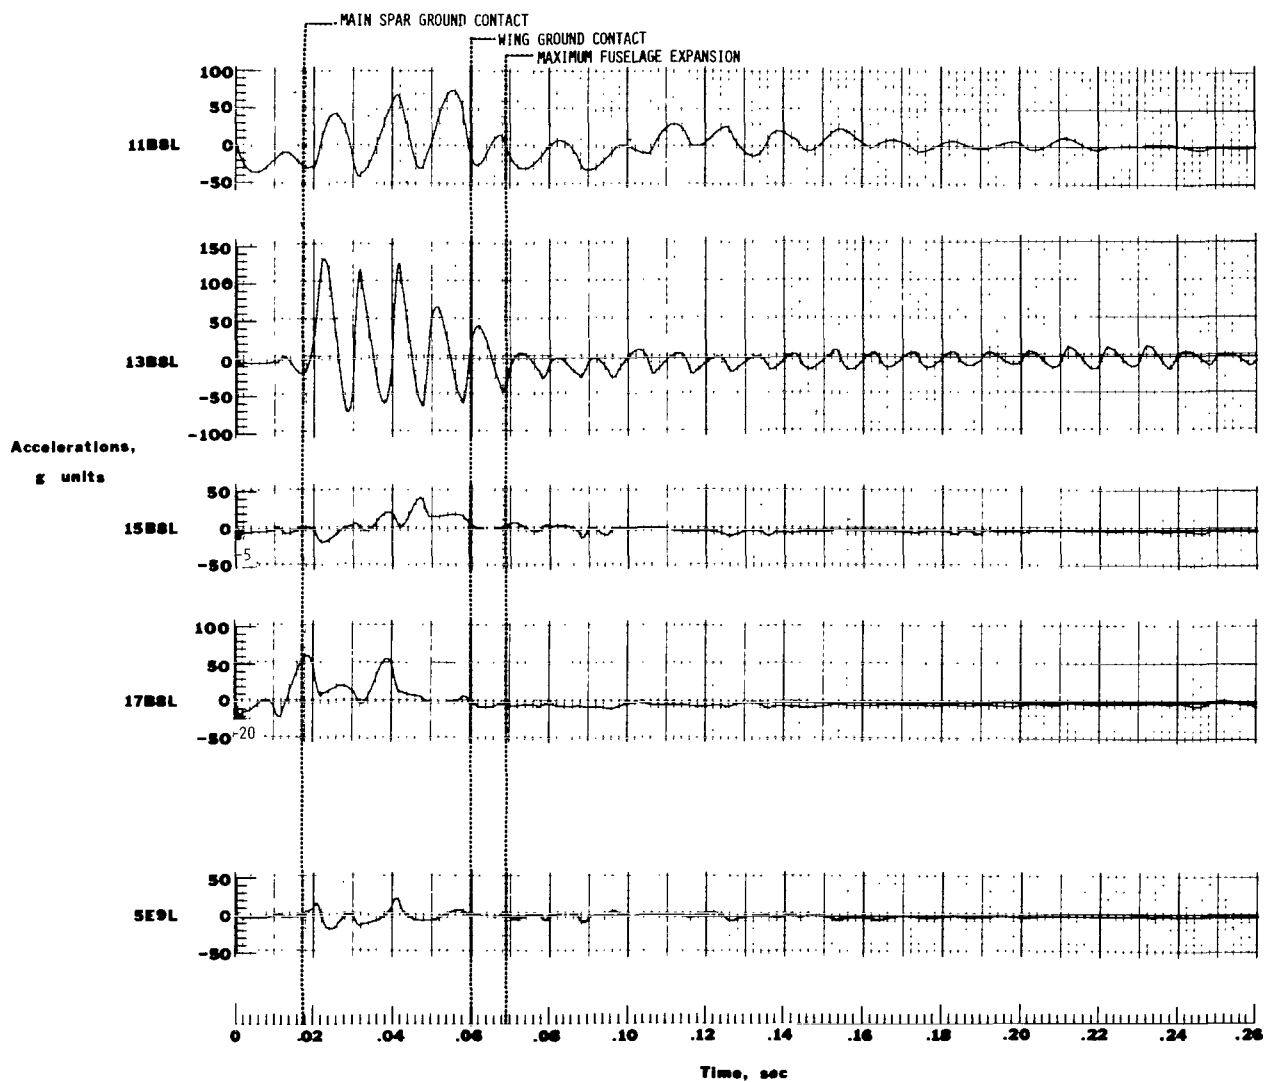
Figure 22.- Continued.

(b) Flat test.

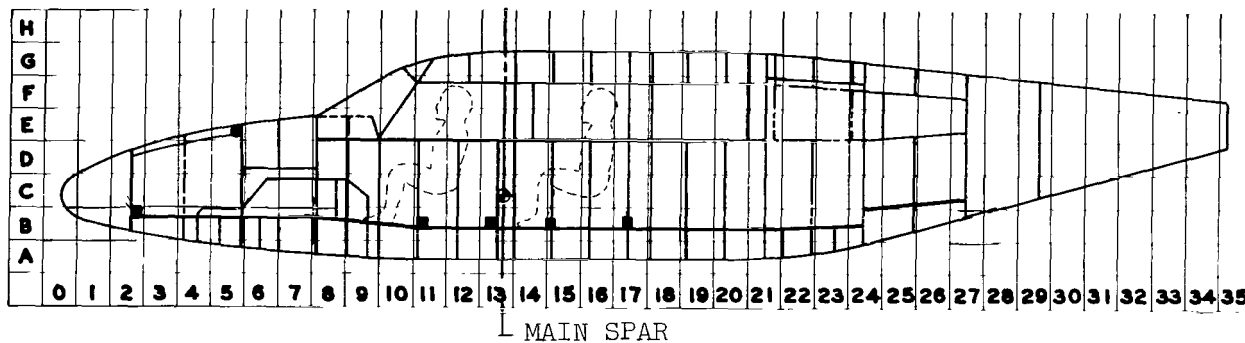
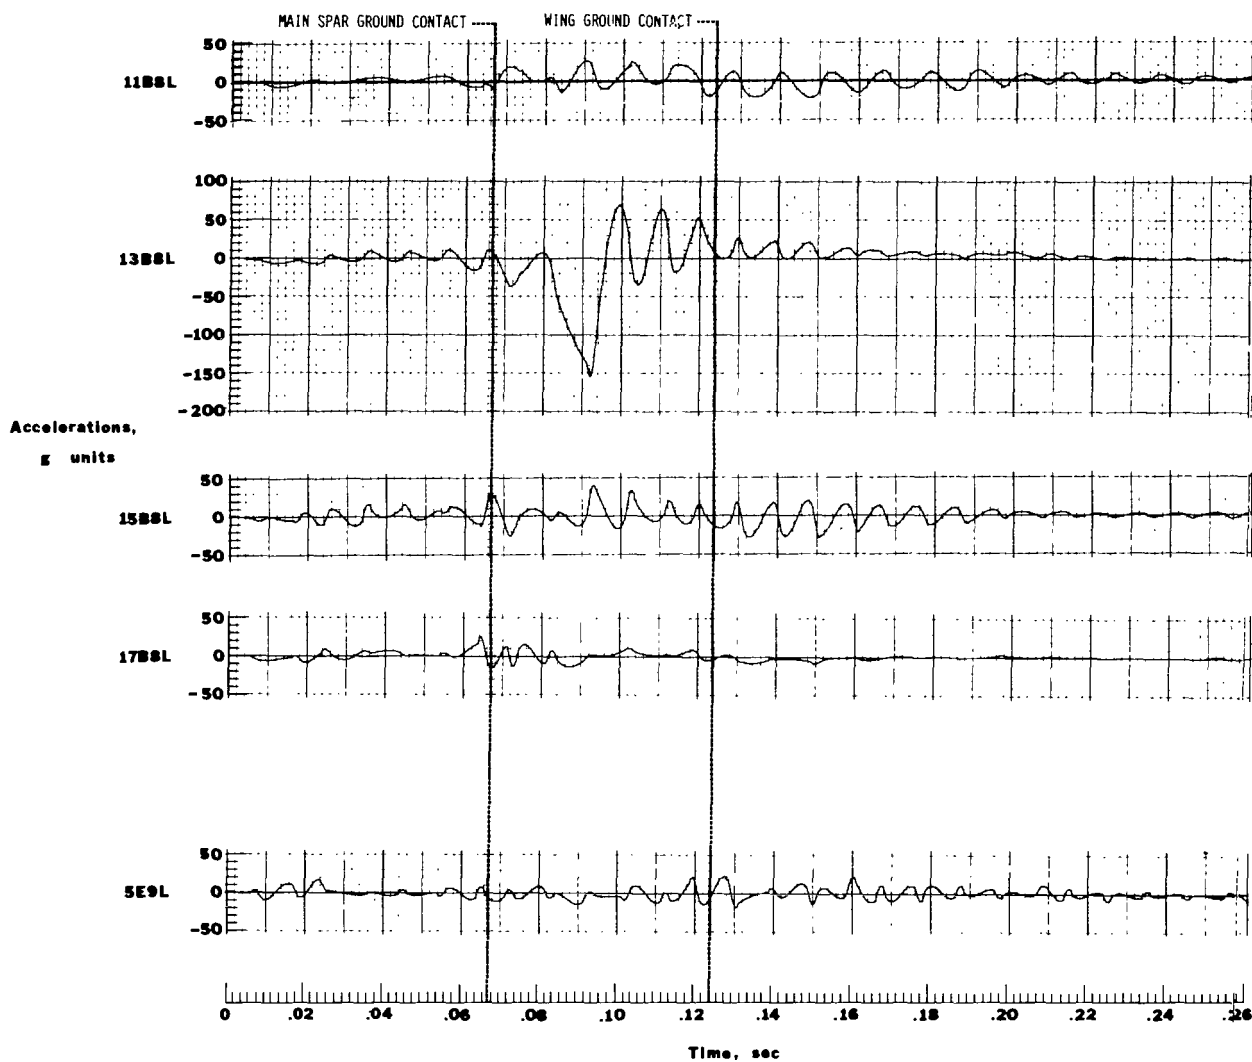
Figure 22.- Concluded.

(c) Pitch-up test.

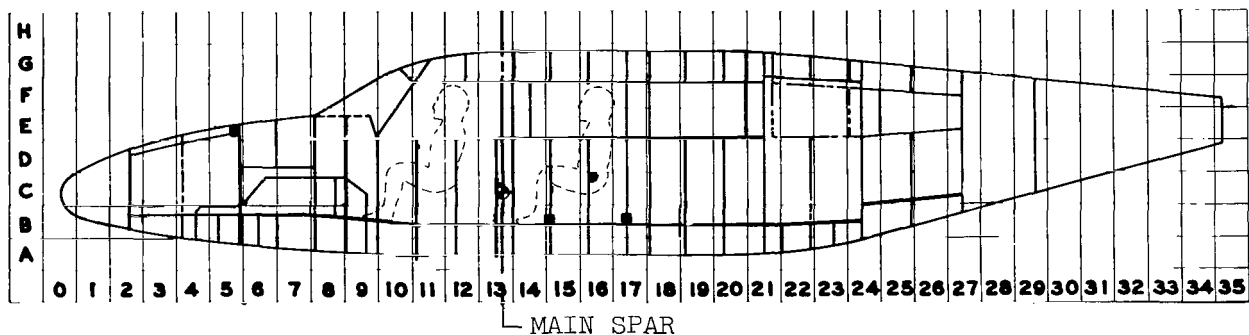
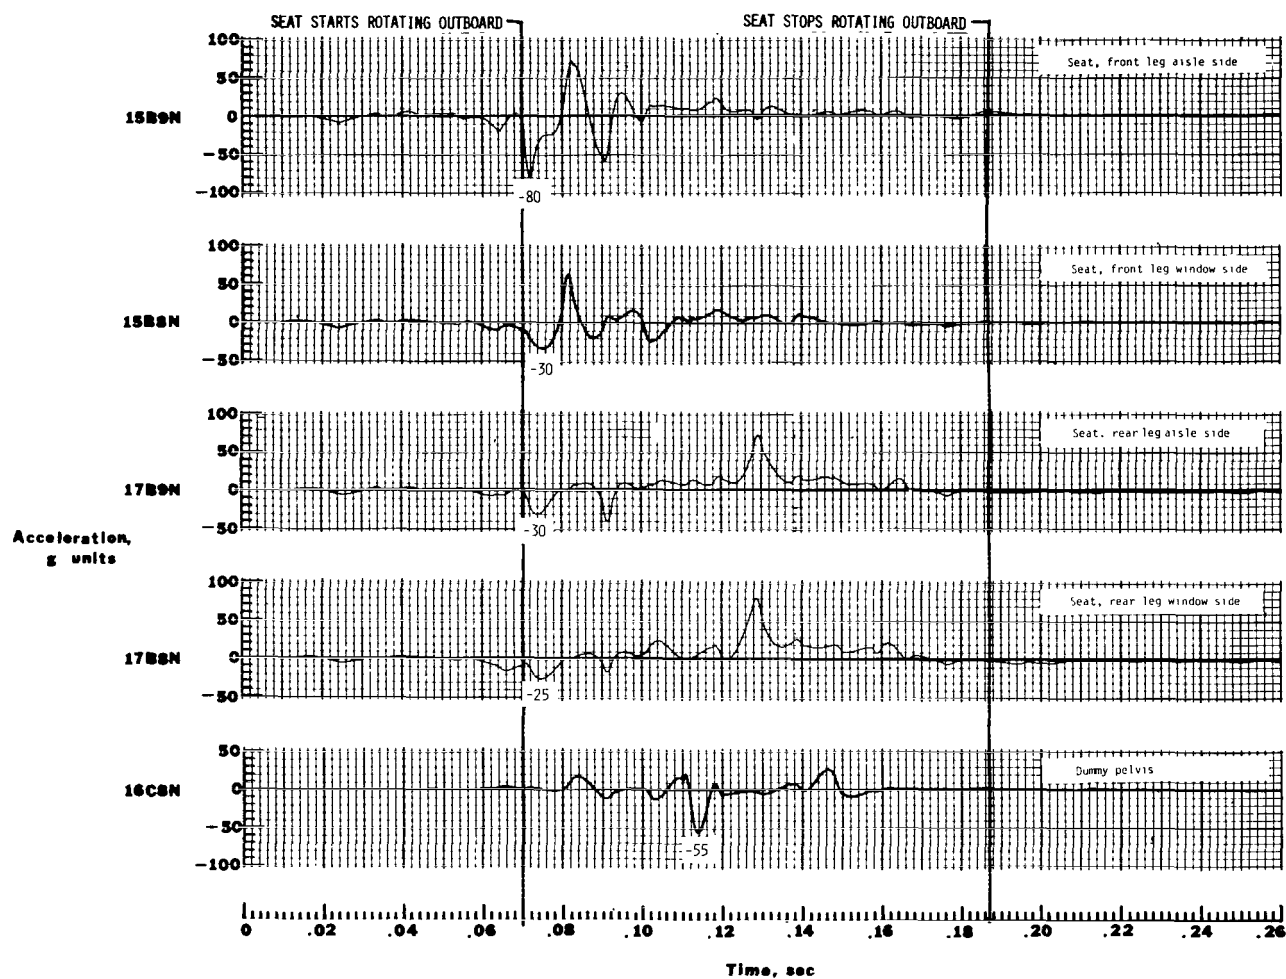
Figure 23.- Histories of normal accelerations on floor at first-passenger seat legs and in dummy.

Pitch-down test.— The normal and longitudinal acceleration histories at the seat legs and in the dummy are presented in figures 23(a) and 23(b), respectively, for the pitch-down test. After the main spar contacted the impact surface (see fig. 19(a)) at 0.05 sec, the floor beam under the dummy experienced normal accelerations of -80g and -30g at the seat front and back legs, respectively. The floor on the window side experienced normal accelerations of -30g and -25g at the seat front and back legs, respectively. The accelerations peaked at about 0.073 sec into the impact. The dummy started to sink into the seat and move forward into the five-point harness restraint system within 0.02 sec after initial ground contact. The dummy experienced only small accelerations as he sank into the seat. The harness system began to tighten at about 0.08 sec into the impact, and the dummy's downward and forward motion was stopped at about 0.114 sec. The resulting delayed pelvic normal acceleration of -55g in the dummy is shown by the peak in the normal direction (fig. 23(a)) and to a greater extent in the longitudinal acceleration of -80g (fig. 23(b)) at 0.114 sec. The seat started to rotate outboard following the deformation of the floor structure at about 0.07 sec, and continued for 0.117 sec. The seat-leg and dummy accelerometers showed negligible accelerations after the seat stopped rotating.

(a) Normal accelerations in pitch-down test.

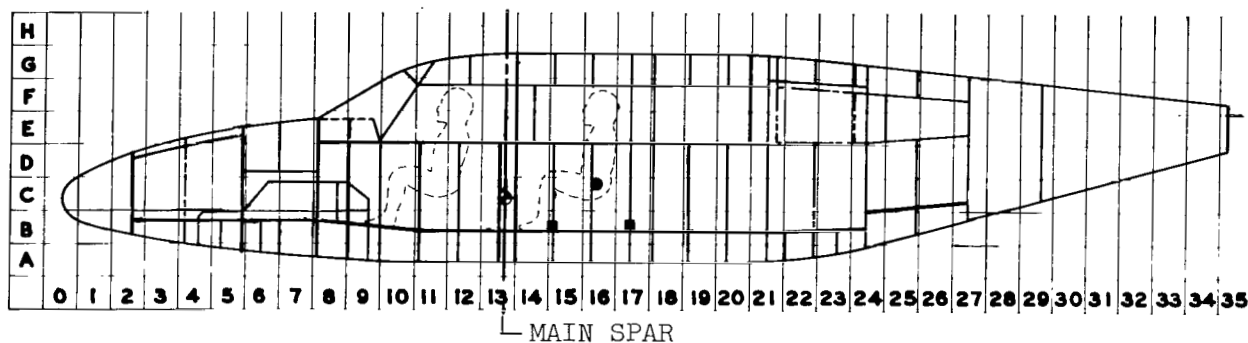
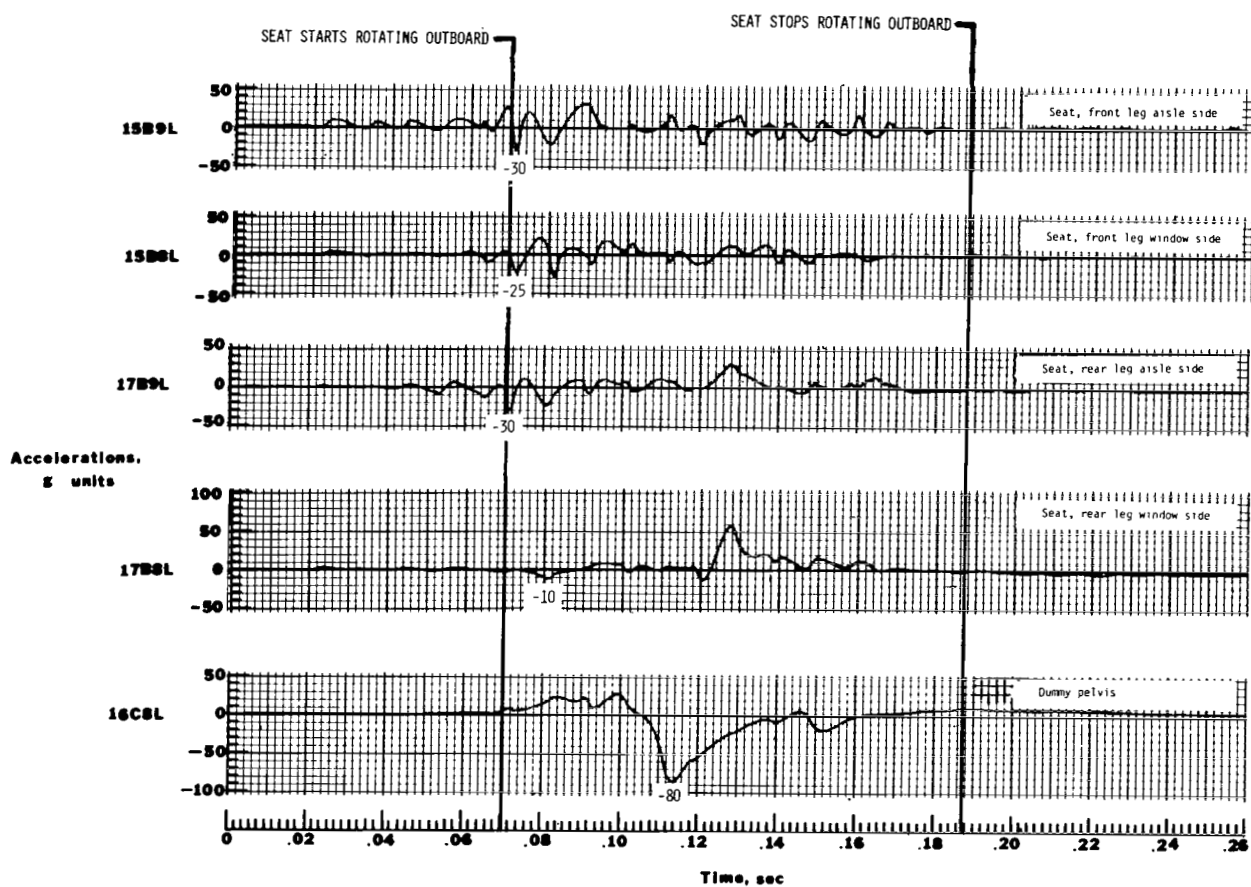
Figure 23.- Continued.

(b) Longitudinal accelerations in pitch-down test.

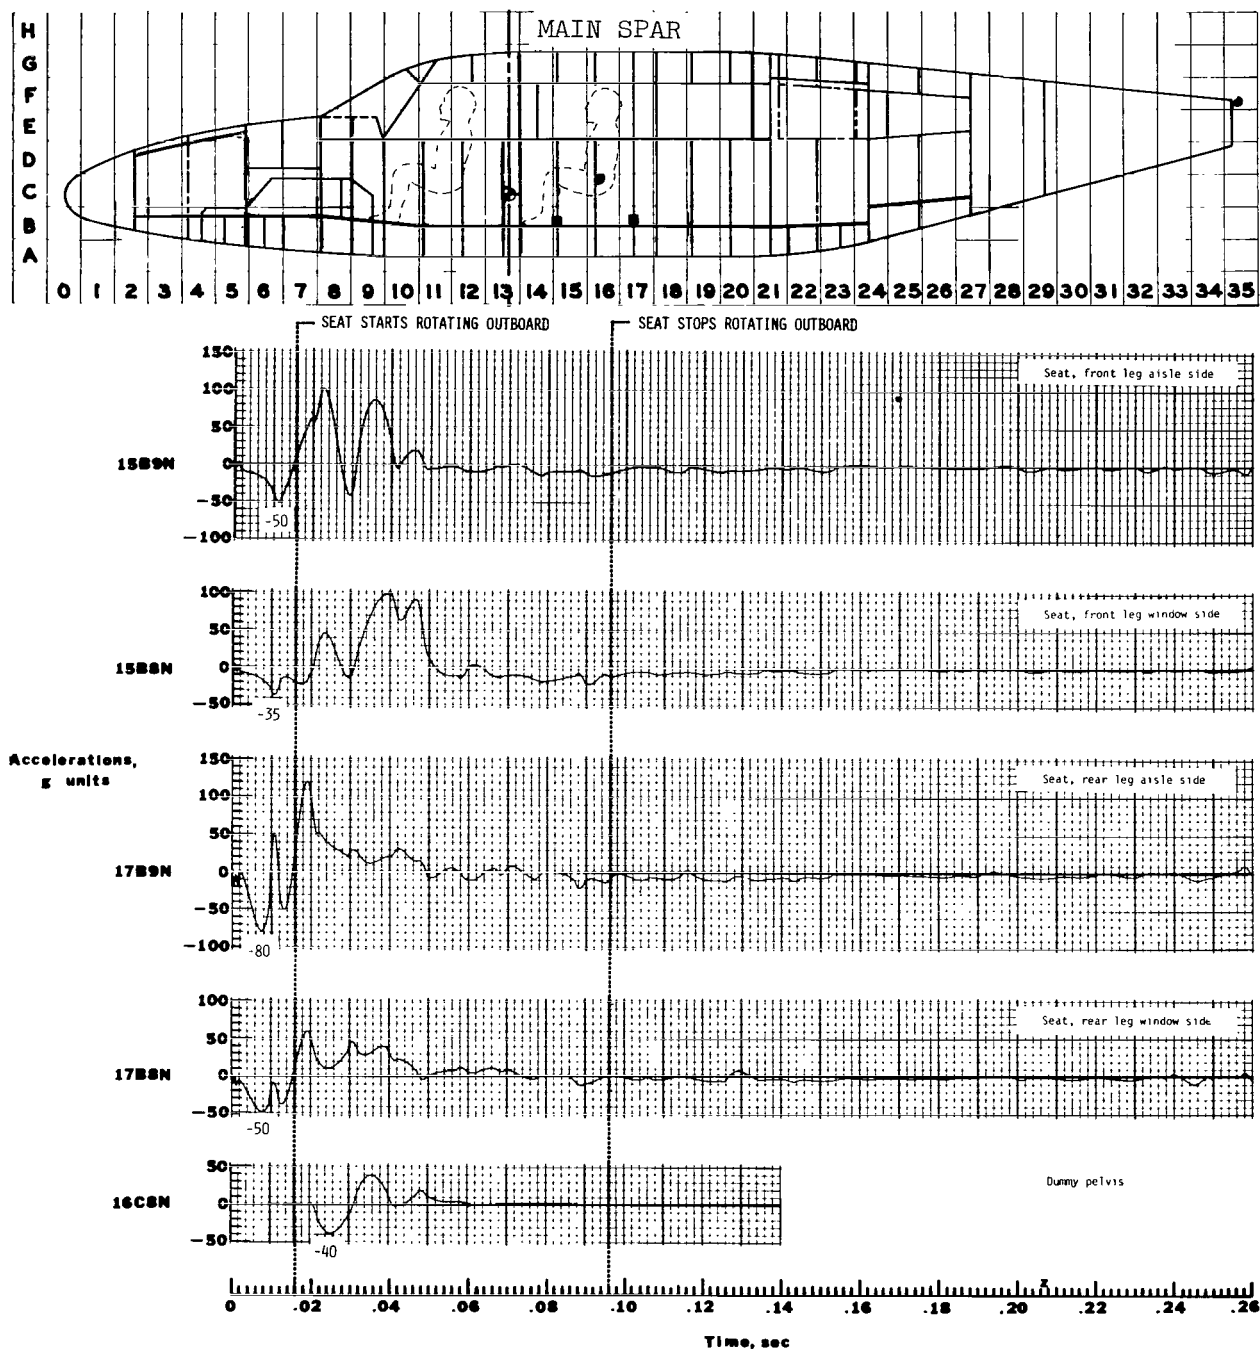
Figure 23.- Continued.

Flat test.— The normal and longitudinal acceleration histories at the seat legs and in the dummy are presented in figures 23(c) and 23(d), respectively, for the flat test. Since the airplane contacted the impact surface at a 4° pitch attitude, the impact acceleration in the first-passenger dummy was felt before the main spar contacted the impact surface. The floor beam under the seat experienced normal accelerations of -80g and -50g at the seat back and front legs, respectively. The floor on the window side experienced normal acceleration of -50g and -35g at the seat back and front legs, respectively. The dummy experienced normal accelerations of -40g and 0.02 sec after those

(c) Normal accelerations in flat test.

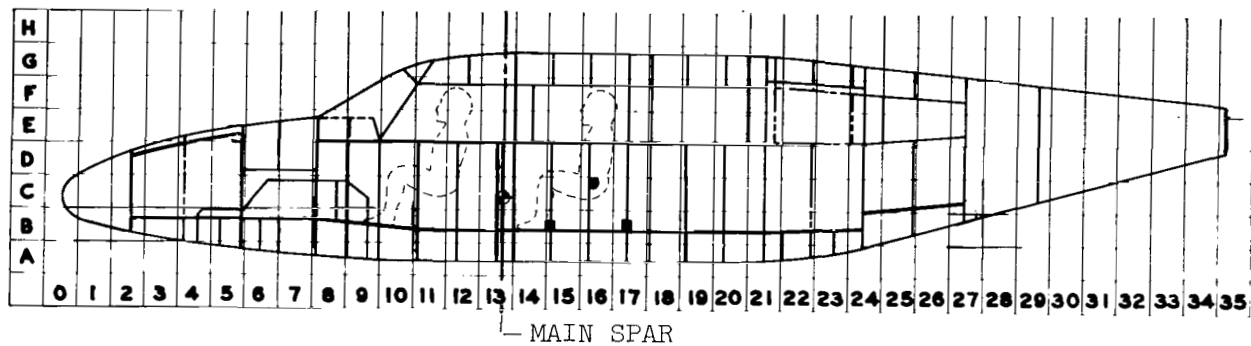
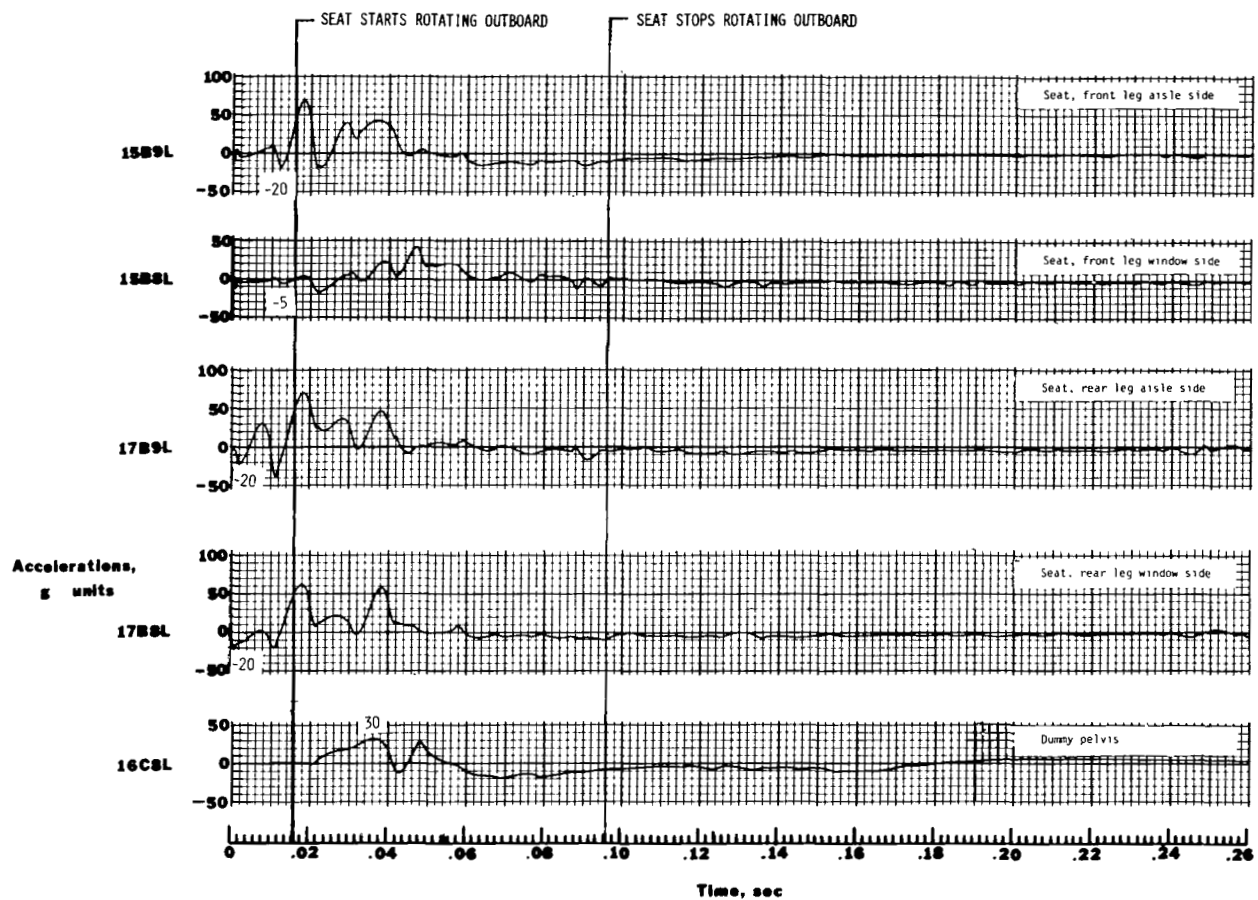
Figure 23.- Continued.

(d) Longitudinal accelerations in flat test.

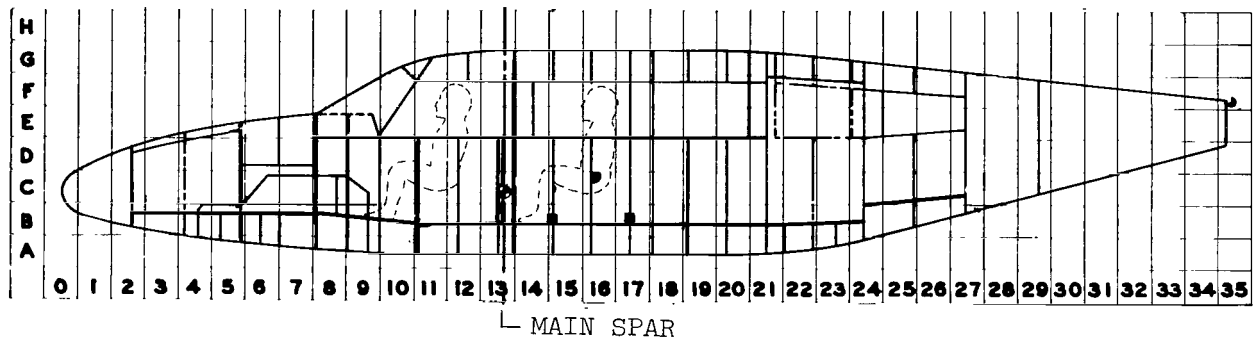
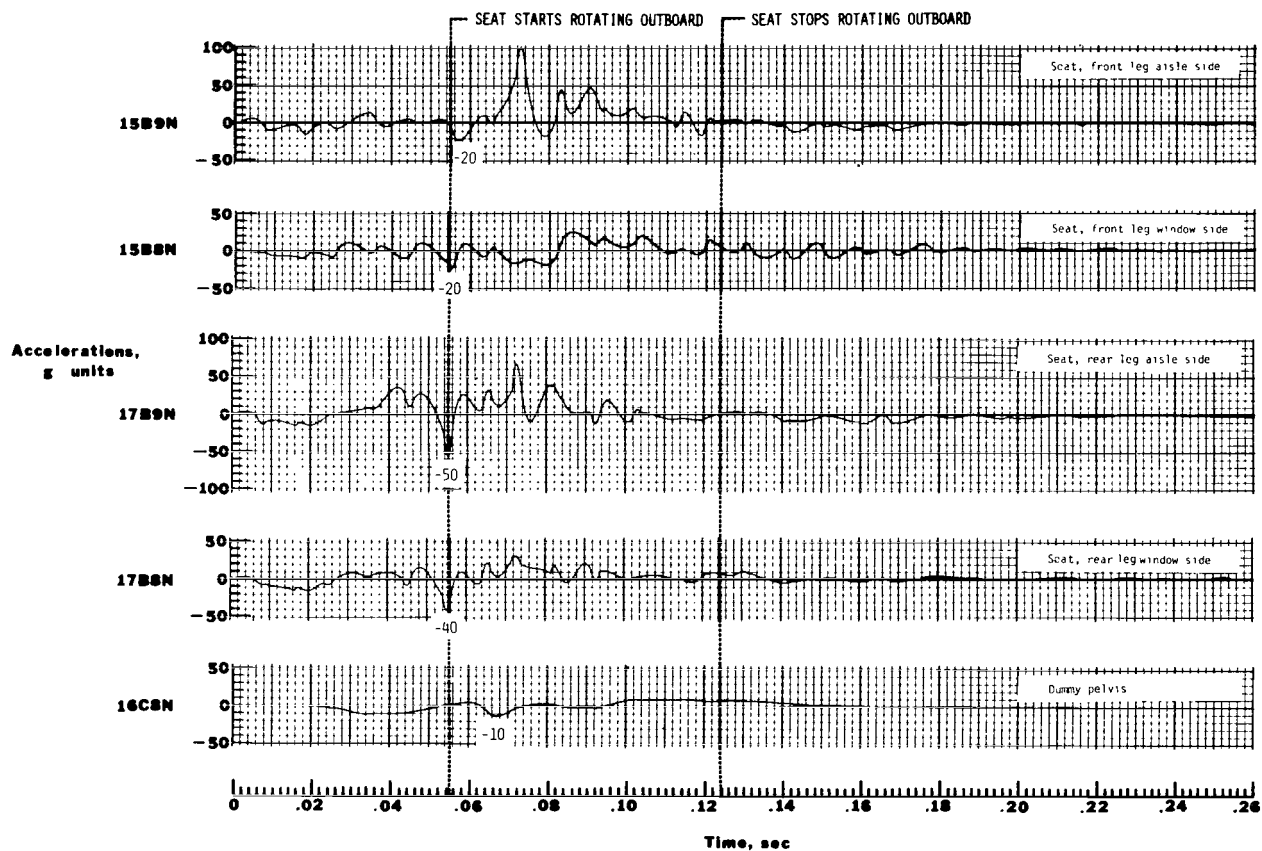
Figure 23.- Continued.

Pitch-up test.— The normal and longitudinal accelerations at the seat legs and in the dummy are presented in figures 23(e) and 23(f), respectively, for the pitch-up test. The effect of the 14° pitch-up angle at ground contact is shown by the greater acceleration at the back legs of the seat than at the front legs. The floor beam under the seat experienced normal accelerations of -50g and -20g at the back and front seat legs, respectively. The floor on the window side experienced normal accelerations of -40g and -20g at the back and front seat legs, respectively. The first-passenger dummy started to move down into the seat within 0.01 sec after ground contact on the aft lower surface of the airplane. The forward rocking motion of the fuselage caused the dummy to move backward into the seat at the same time that he moved down into the soft seat cushion and supporting diaphragm. At 0.053 sec after ground contact, the dummy stopped his downward motion. At the same time, the normal accelerations at the seat legs peaked (negative magnitude, fig. 23(e)). As the dummy's sinking motion stopped, the dummy started to submarine under the lap belt which was attached to the seat at the floor. At the same time, the seat started to rotate outboard, causing a positive response to the dummy's longitudinal accelerometer (fig. 23(f) and accelerometer 16C8L). The accelerometer was oriented along the longitudinal axis of the dummy (perpendicular to the spine); however, the submerging caused the accelerometer to rotate into an orientation almost parallel to the airplane normal axis (see fig. 24). Consequently, response of the longitudinal accelerometer was due to the stopping motion along the normal axis of the airplane. The acceleration of 30g peaked at about 0.065 sec into the impact. At 0.067 sec after ground contact, the airplane downward velocity was arrested, and rebound of the floor beams started as the airplane continued to rock forward. The reversal of direction caused positive normal acceleration peaks on the floor beam at the base of the seat. The seat continued to rotate outboard until 0.124 sec, after which time all accelerations were negligible.

(e) Normal accelerations in pitch-up test.

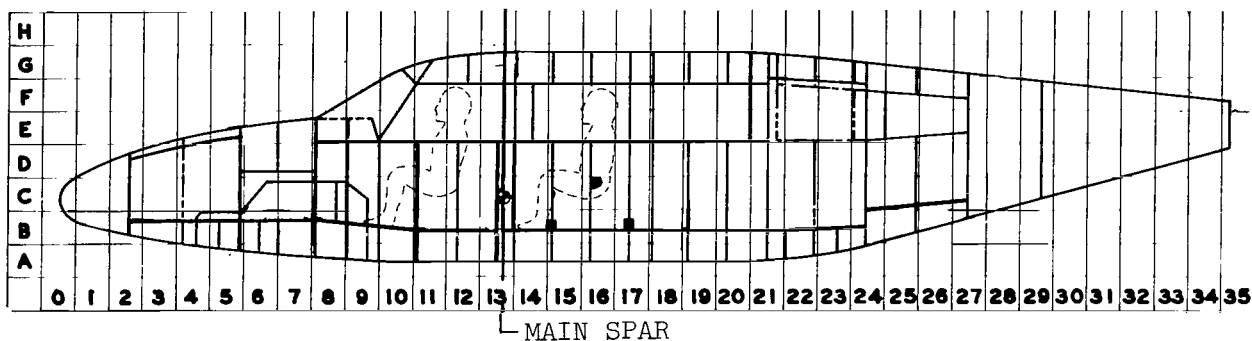
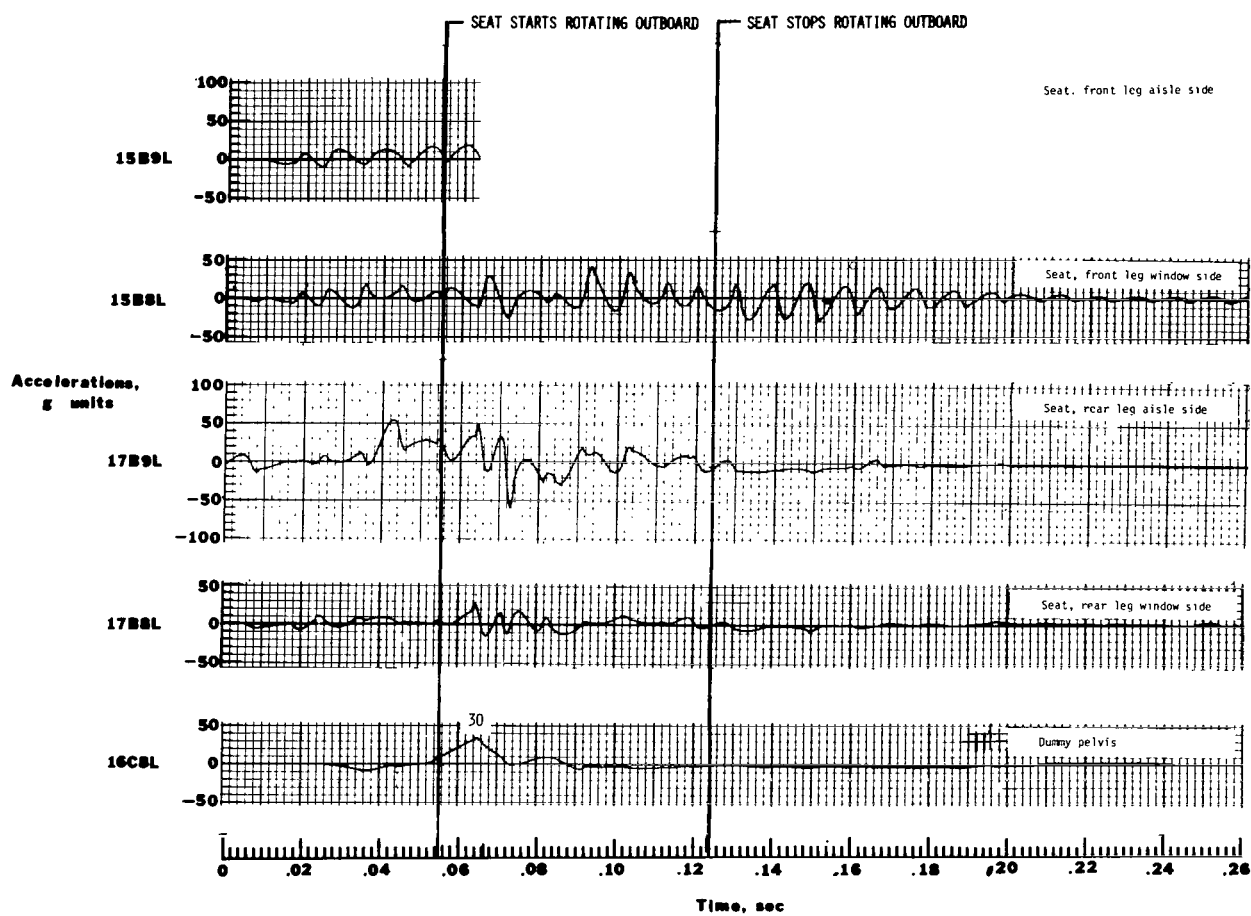
Figure 23.- Concluded.

(f) Longitudinal accelerations in pitch-up test.
